Consumer Complaints for Vibration -Tire/Rim Slip-

Nitto recently completed a test of four tire brands, including Nitto, revealing that tire slip on wheels is a major cause of vibration leading to customer complaints after mounting new tires and wheels.

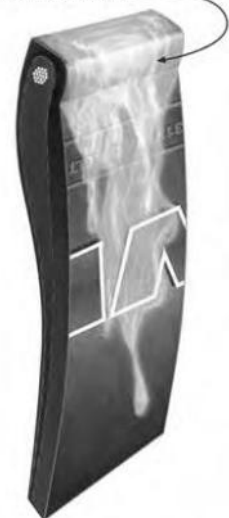
INCORRECT APPLICATION
OF LUBRICANT

The main cause of tire/wheel slip is excessive use of tire lubricant (shown on the right) on the tire beads and rim. Excessive lubricant reduces friction between the tire bead and the wheel, allowing the tire to slip within hours of mounting.

1. **For new tire and wheel assemblies, clean the tire beads of any manufacturing related lubricants with an approved rubber cleaner fluid commonly used in the tire repair process.**
2. **Clean the wheel bead seating area.**
3. **Use a sponge and a paste-type lubricant to lubricate the tire bead sole according to the photo shown to the left.**

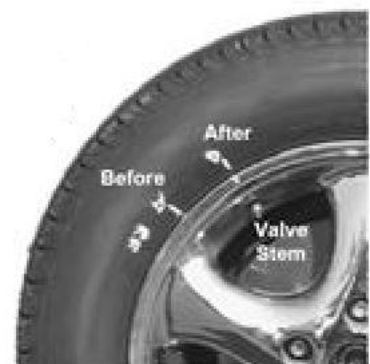
3" Slip After Mild Driving

All of the test tires, regardless of brand or driving mode, slipped on the rim causing the assemblies to go out-of-balance. Nitto confirmed the results with several tire shops that monitored tire/rim slip by indexing the valve stem to the tire sidewall. One shop reported 3 inches of slip 12 hours after mounting and balancing resulting in a ride complaint.
